REPORT NUMBER: RED-04-01

REPORT ON EARLY DISTRESS (RED)

**Investigation of Shoulder Heave Problems
on
I-90, Monroe County (and other State Hwys)**

FINAL REPORT

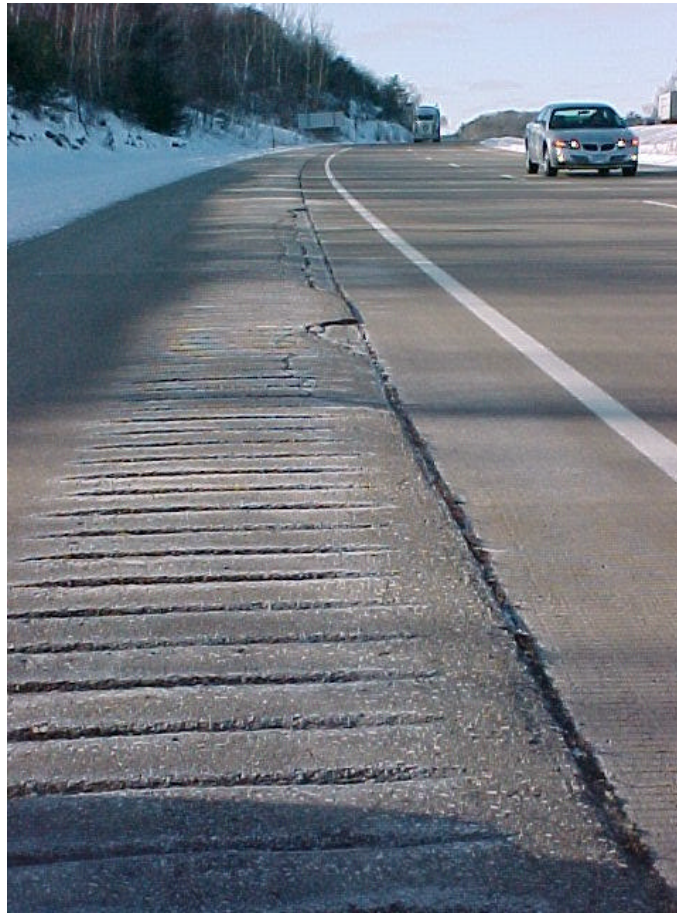
Print 1. Showing shoulder heave and break up on the east bound lanes.

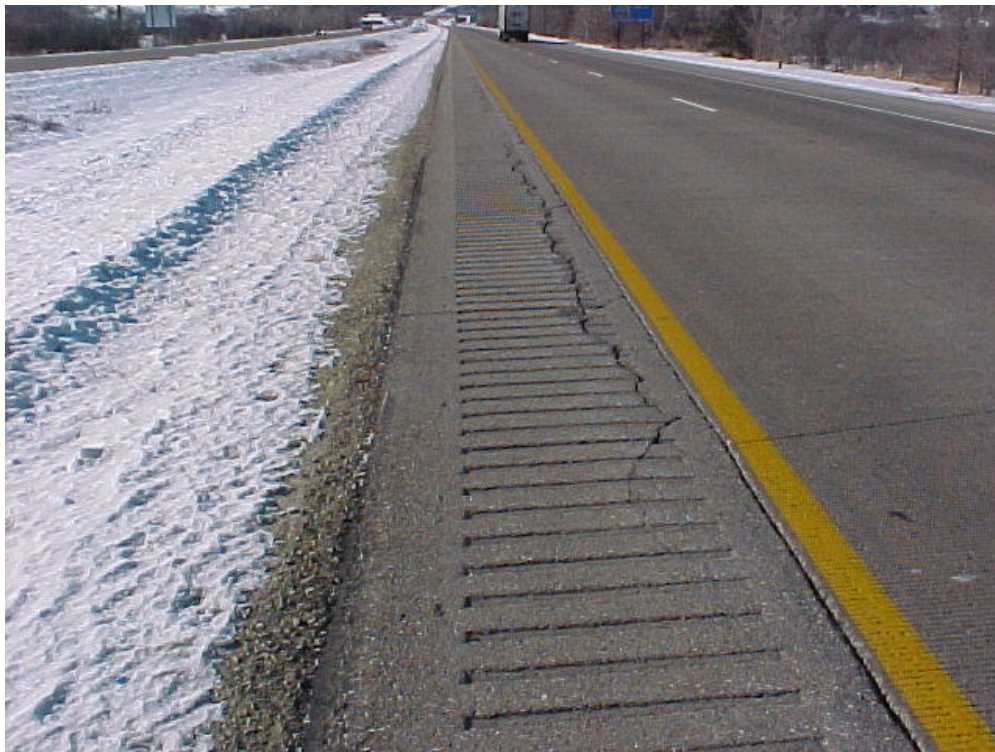
Print 2. View of shoulder breaking up on the west bound lanes.

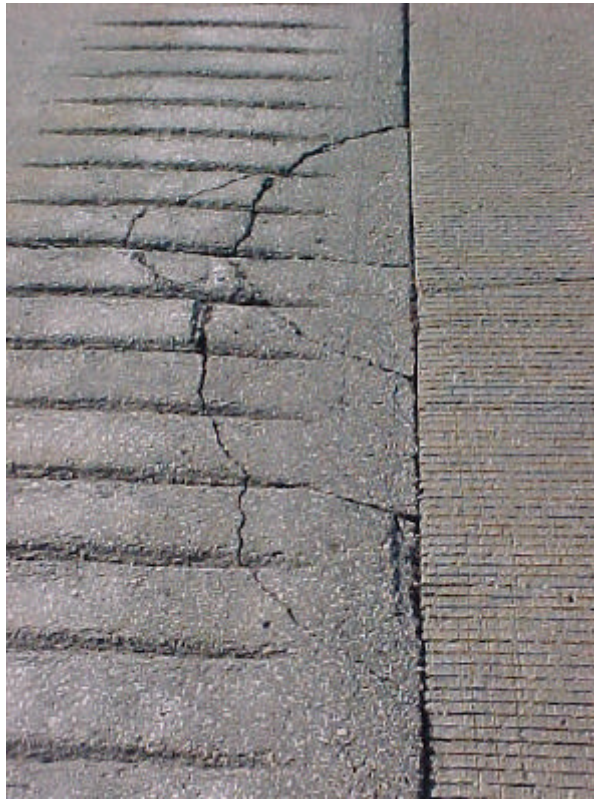
Print 3. Close-up of the shoulder heave and subsequent break up.

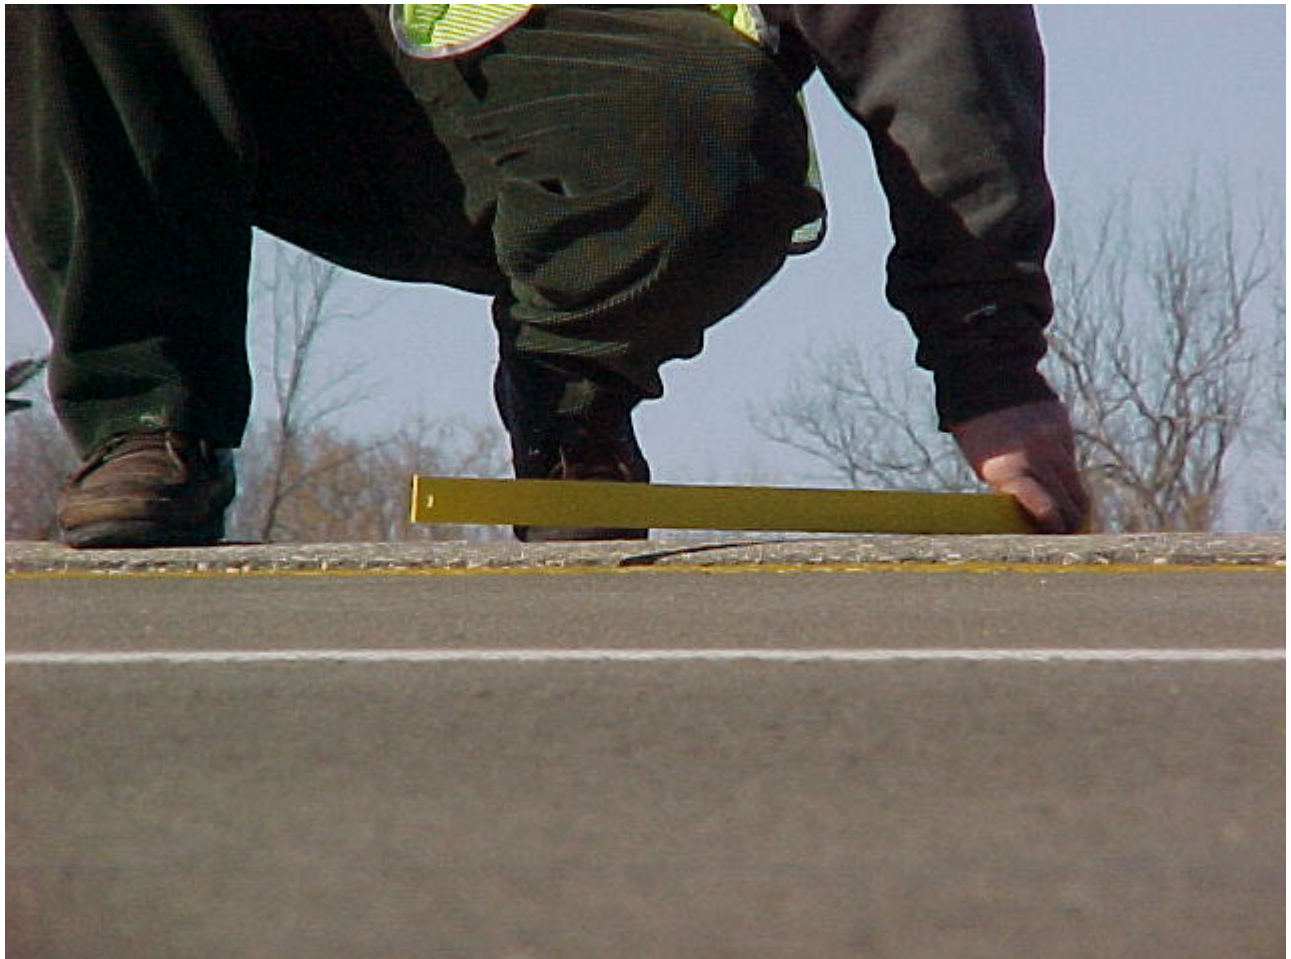
Print 4. Straight edge used to show relative shoulder heaving height (approx. 2 inches).

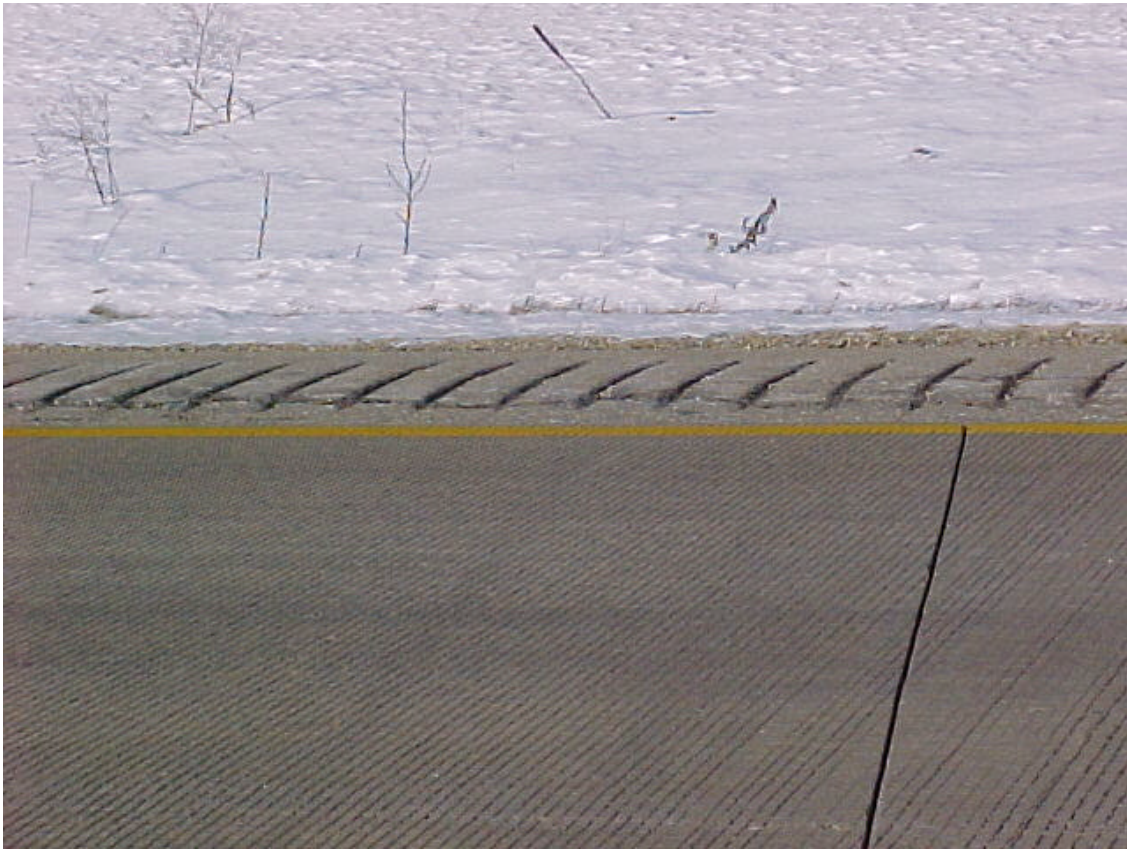
Print 5. Another view of a distressed area of a heaved shoulder.

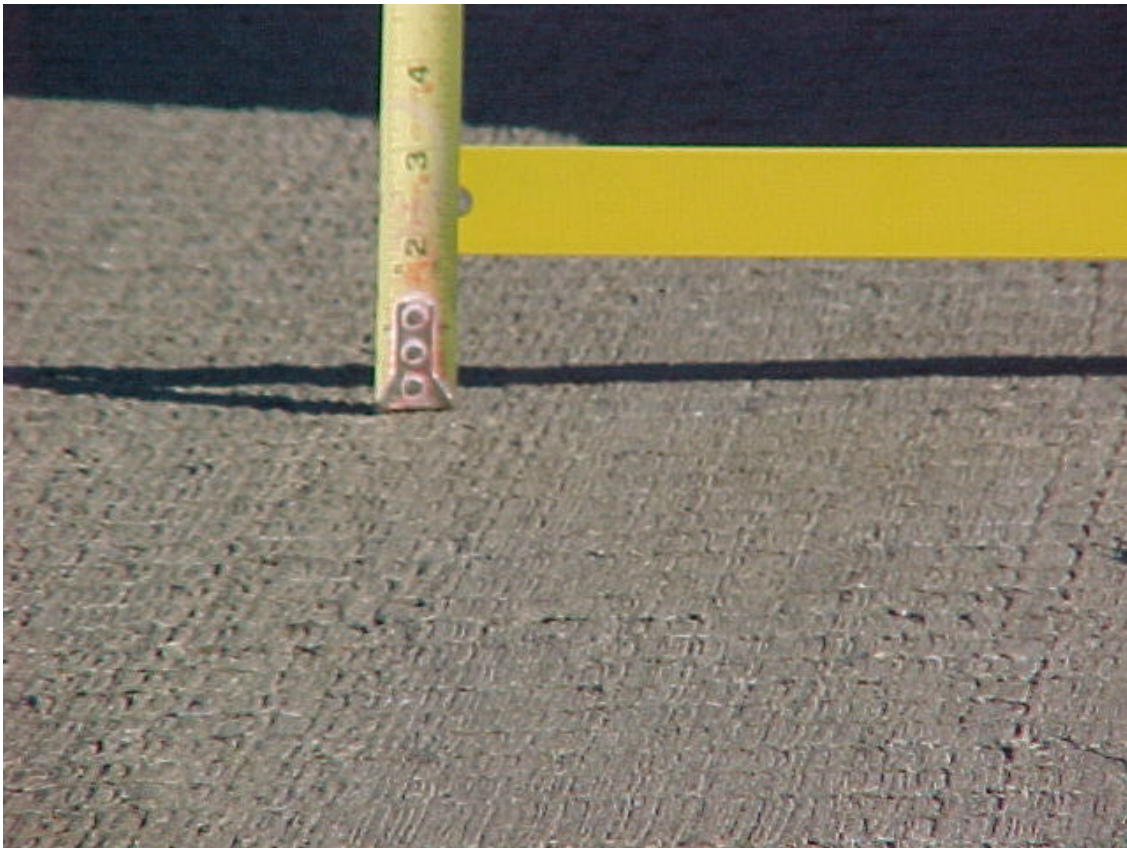
Print 6. Showing the approximate 2 inches of shoulder heaving with a straight edge.
